IN THE HIGH COURT OF JUDICATURE AT MADRAS

W.P.Nos.27356 of 2019 and 28266 of 2022
& W.M.P.Nos.13292, 13294, 35572, 36994 and 37000 of 2024

Prayer in W.P.No.27356 of 2019 :- Writ Petition filed under Article 226 of the Constitution of India, pleased to issue a Writ of Mandamus directing the 1st respondent to secure the 16 elephant corridors in the state of Tamil Nadu with the support of the other respondents.

COMMON ORDER

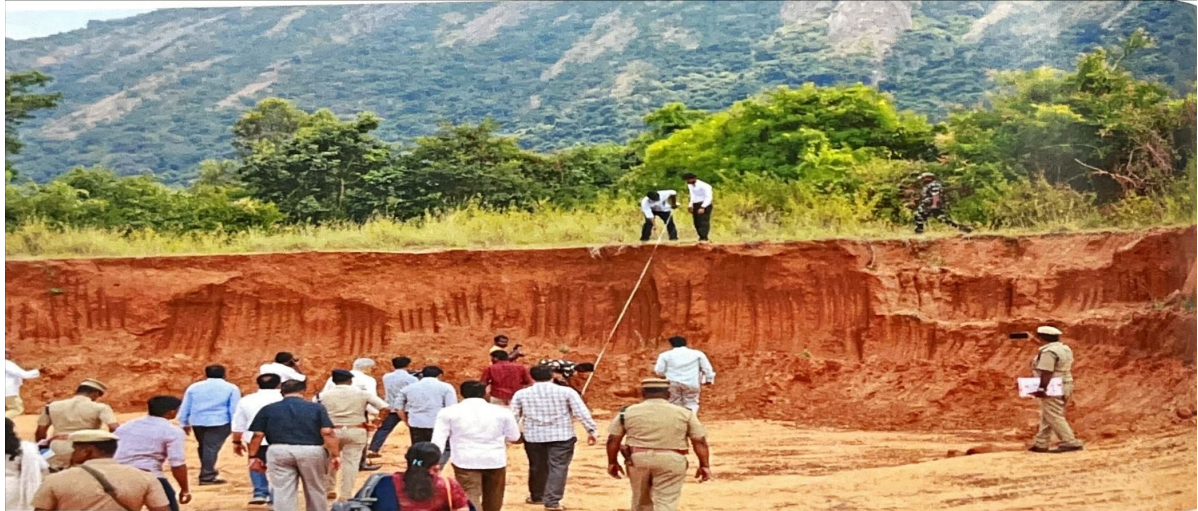
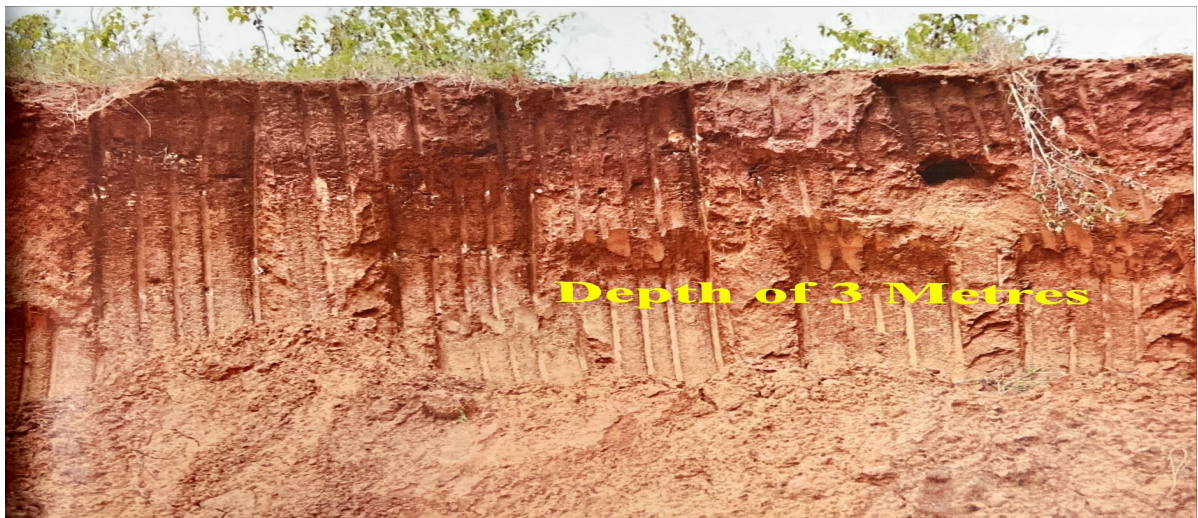
14. The mining shows that heavy machineries such as J.C.Bs are being used and the marks are very well visible. The following is the one of the

pictures of the said site:-

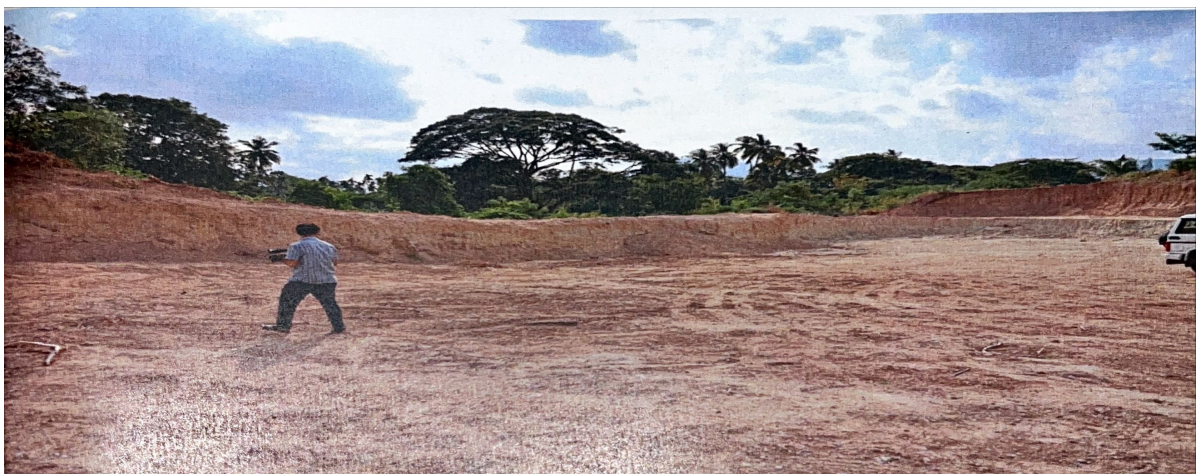
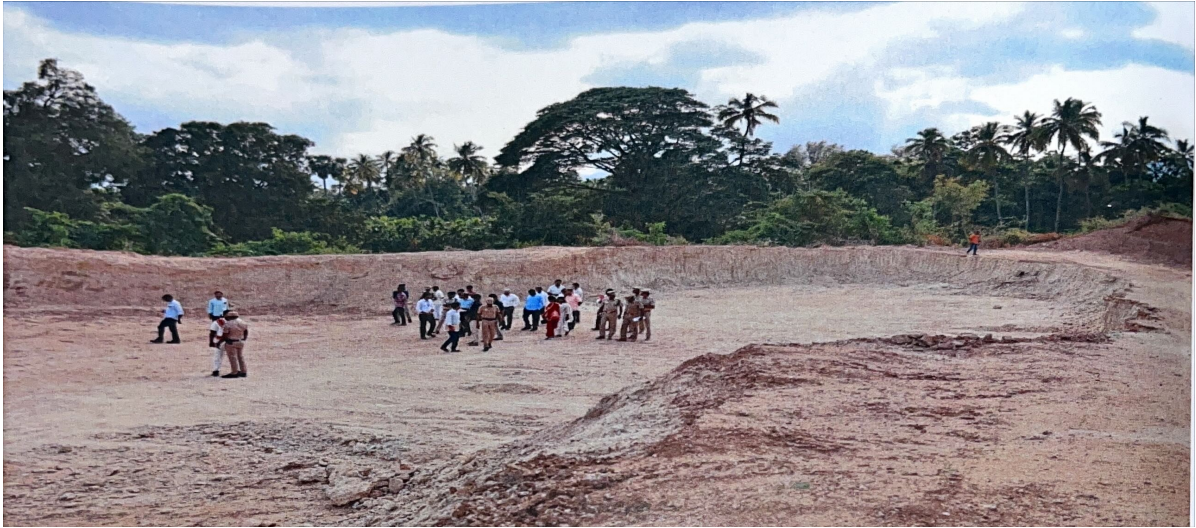
16. In Kottaikadu village, in vary poramboke, which is a water body in S.F.No.766/1 of Ikkarai Boluvampatti village, a vast extent of illegal mining is noticed. The following images would definitely shock conscience of any person :-

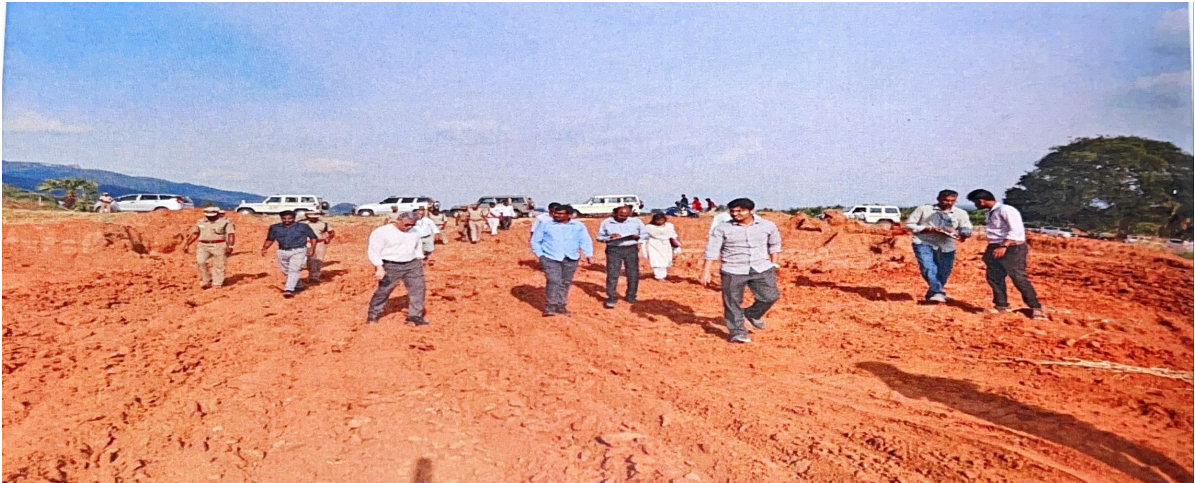
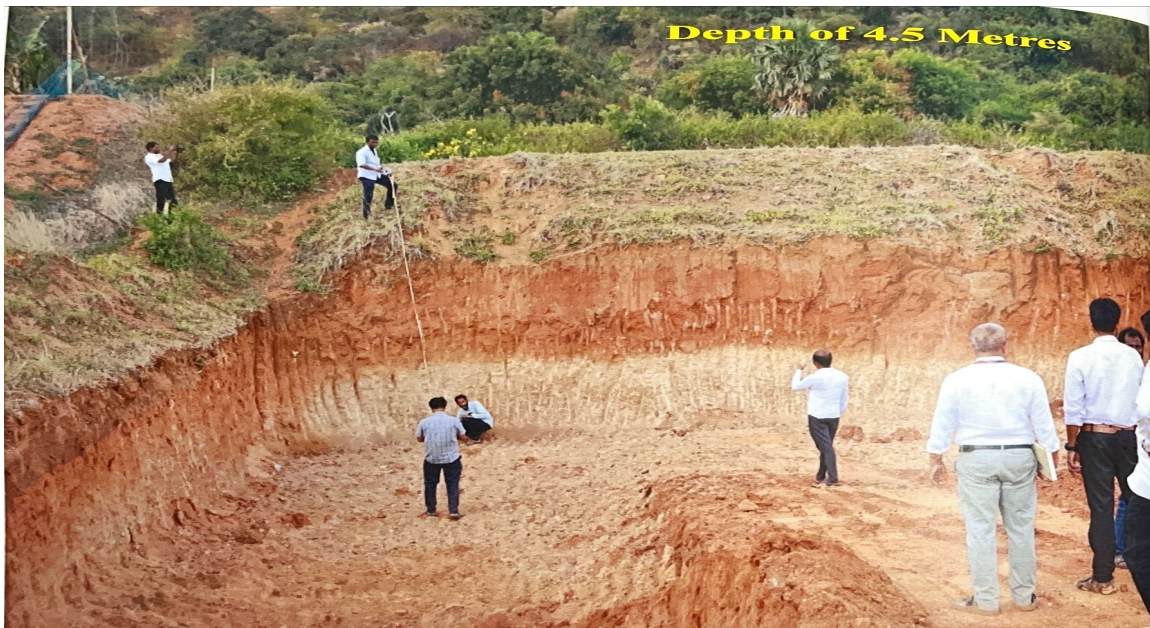
17. It is reported by the Boluvampatti Village Administrative Officer that he also lodged a complaint only on 01.10.2024 and C.S.R.No.261 of 2024 was issued as on the date of inspection. When S.No.54/2 of Vellimalaipattinam was inspected, removal of red soil in multiple stages to the depth of 4.5 meters, was noticed. This removal is very near to the Reserve Forest boundary. The removal of earth is huge and vast and to a great depth of 4.5 meters. The following pictures show the vastness of the area and the depth of 4.5 meters of earth quarried:-

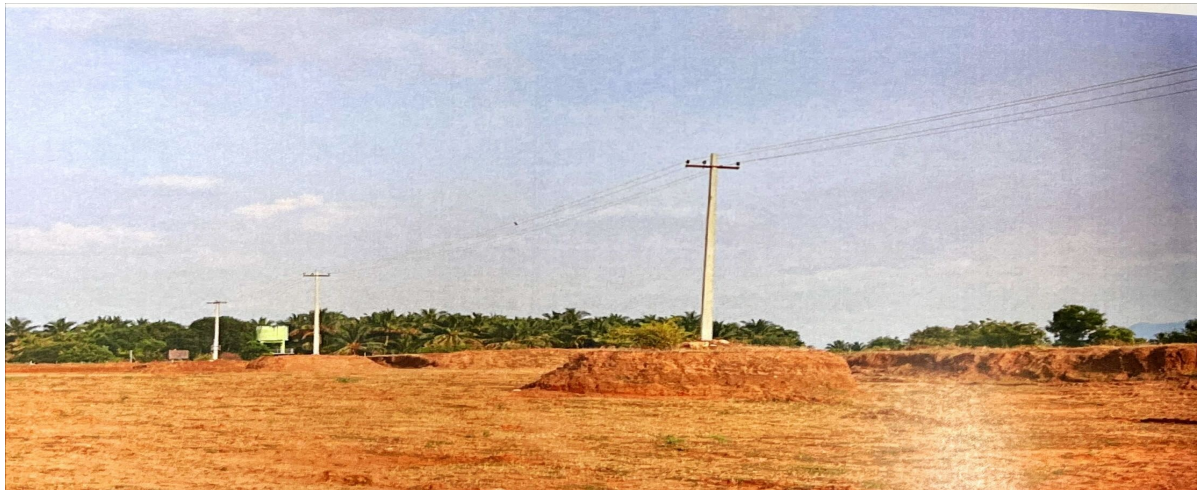
19. In Devarayapuram, quarrying is done and a trench like way is created by widening the water stream and meddling with the same so that lorries can pass through. In a patta land in S.F.No.248/1A, the quarrying was done. There also, a complaint was given on 22.09.2024 and a case in Crime No.210 of 2024 was registered in the Thondamuthur Police Station. Removal of huge earth from the land belonging to one *Kuttiammal* was noticed to a depth of about 4

feet and even the electric polls are dangerously standing and the following picture would demonstrate the manner and extent of quarrying:-

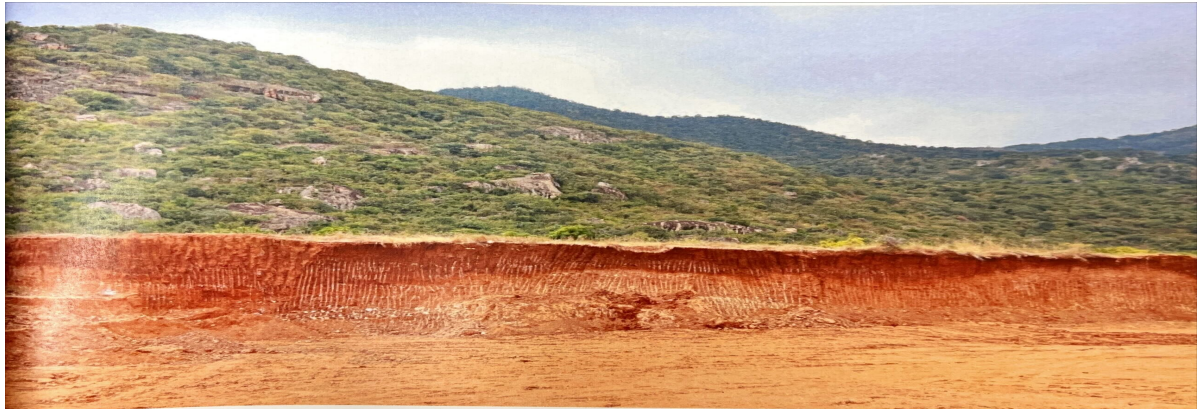
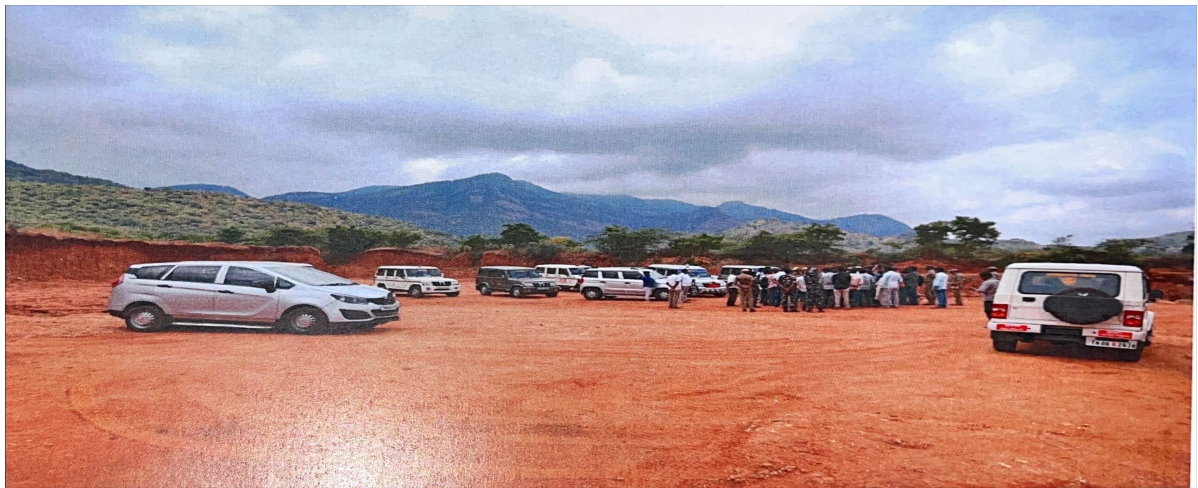
20. In Karadimadai, the inspecting authority found the trenches which are made by the Forest Department to prevent man-animal conflict being obliterated and mud roads are formed for legal transport of the earth. On an inspection of the patta lands of one *Sadavisam* in S.F.No.393/4A and 393/4B, the inspecting authority was shocked to see a wide range of red sand and gravel rampantly removed in a continuous extent just 500 meters away from the Reserve Forest boundary. The whole place looks larger than a football ground.

The manner, in which the quarrying is made and the extent can be known from the following pictures :-

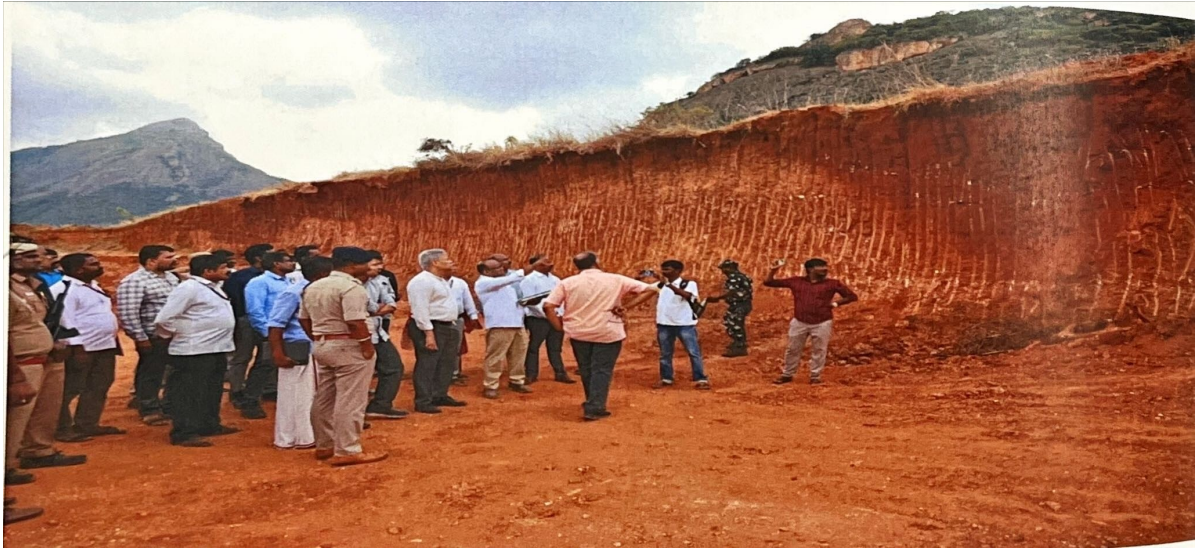
21. The danger of land slide and the hillocks disappearing can be gauged from the following picture :-

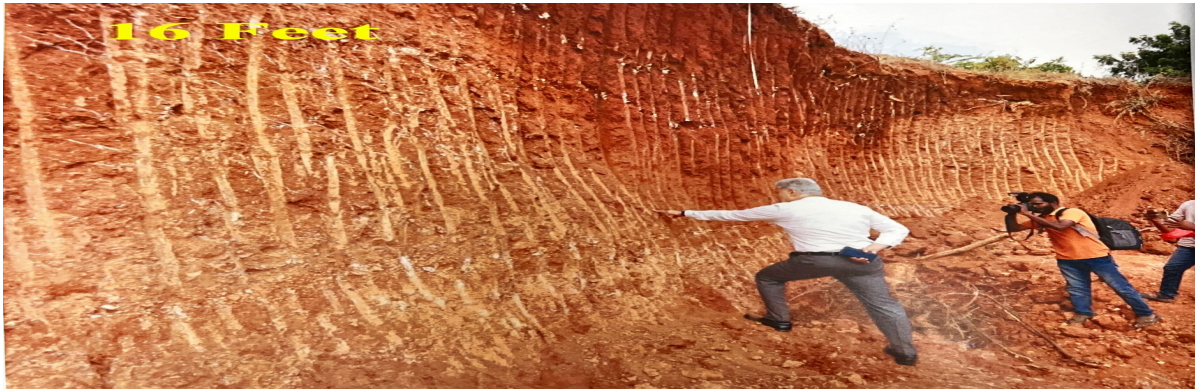
22. The J.C.B's scratch marks clearly show the manner, in which, the quarrying was done. The quarrying was done to a depth of about 16 feet, which can be clear from the following picture :-

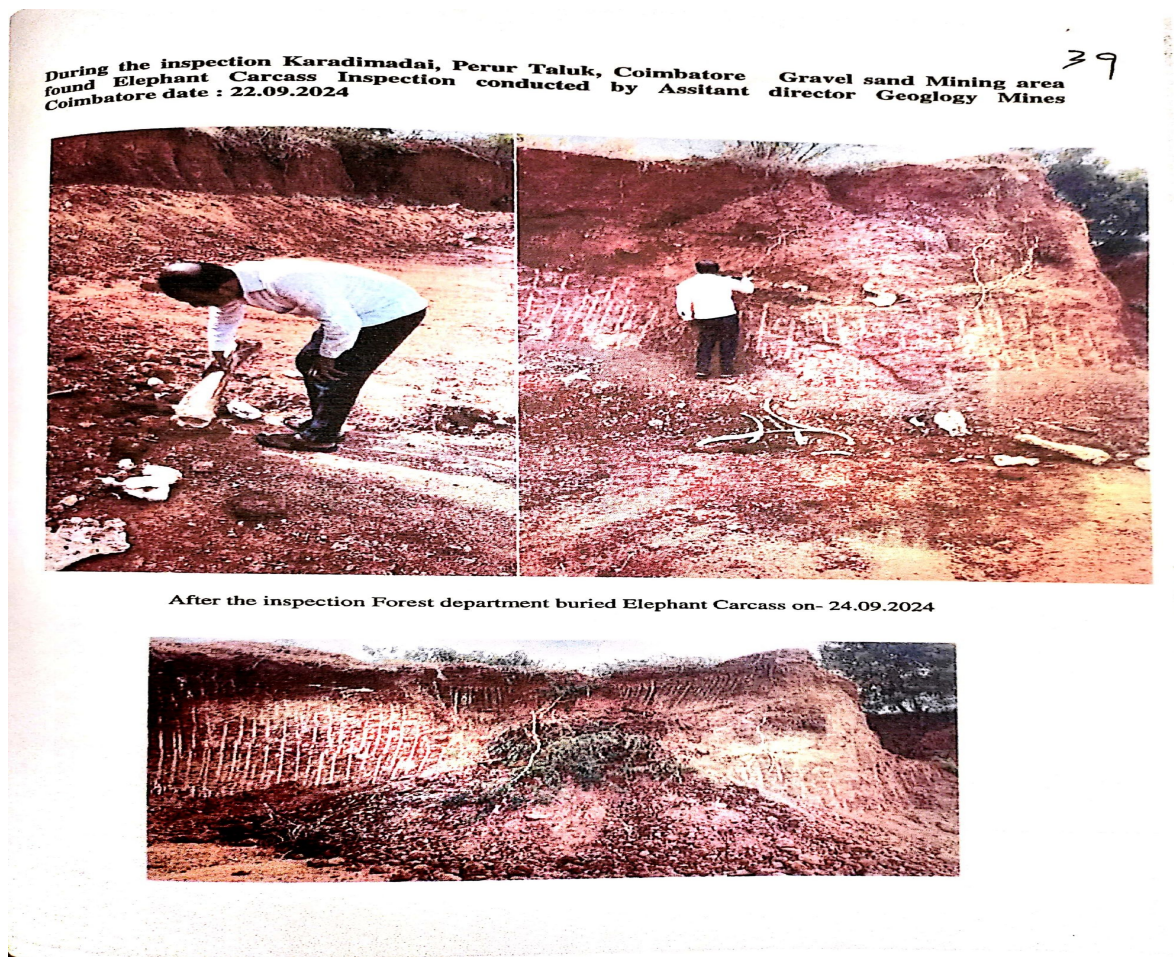
23. As a matter of fact, when the Collector earlier inspected the spot, a carcass of an elephant was also found being excavated on account of the huge amount of quarrying and the following picture demonstrates the same:-

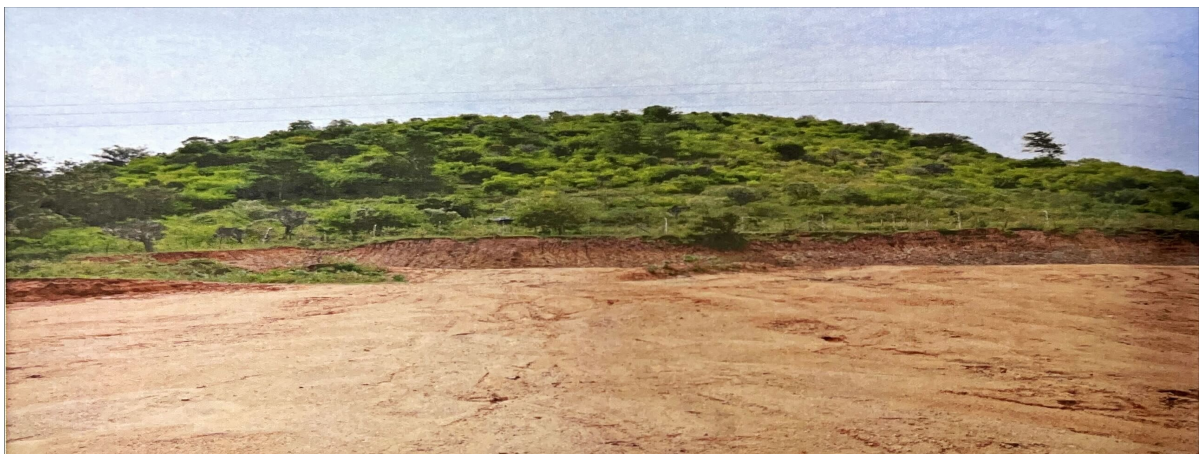
26. Two groups of villagers were also accusing each other and they were showing allegation as against land owner of removing huge earth even taking away the pathway. The S.F.No.1039/1 in Thekkalur village is a hillock covered by bushes and trees with a green cover, however, now, shaved off its greenery and is almost levelled changing the very nature of terrain itself. The following picture of the Inspection Report would demonstrate the nature of quarrying:-

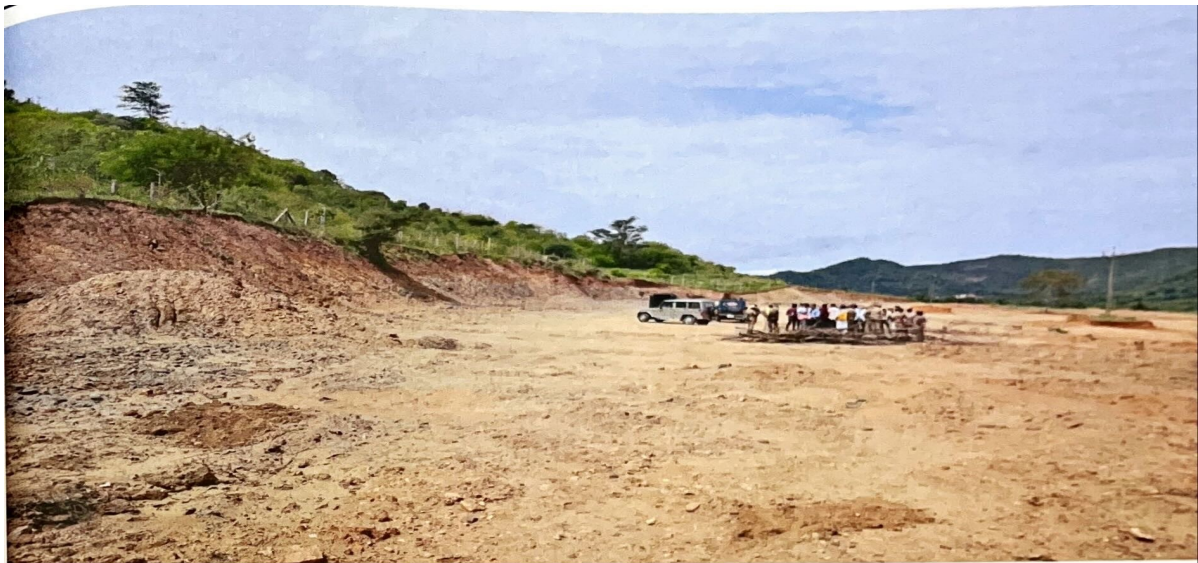
27. Field map also shows water streams running through these fields.

The vast extent of clearance of earth can be gauged from the following picture:-

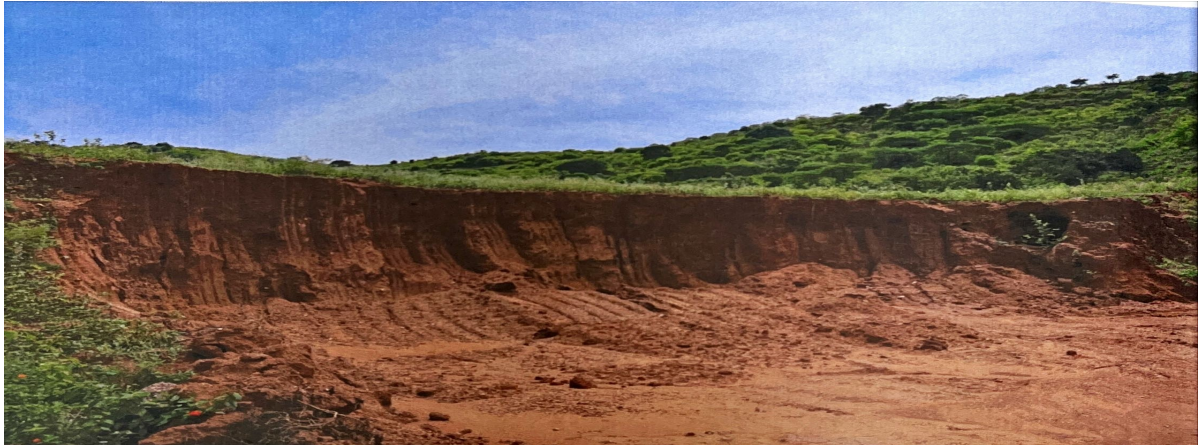
28. The water streams were also noticed and erection of electric fences hampering the movement of the wildlife was also noticed. In several places, erosion of soil, on account of this quarrying, was also noticed. The S.F.No.1016/1, Aniakatti was also inspected. The manner in which huge

excavation has taken place abetting the hilly areas can be seen from the following picture:-

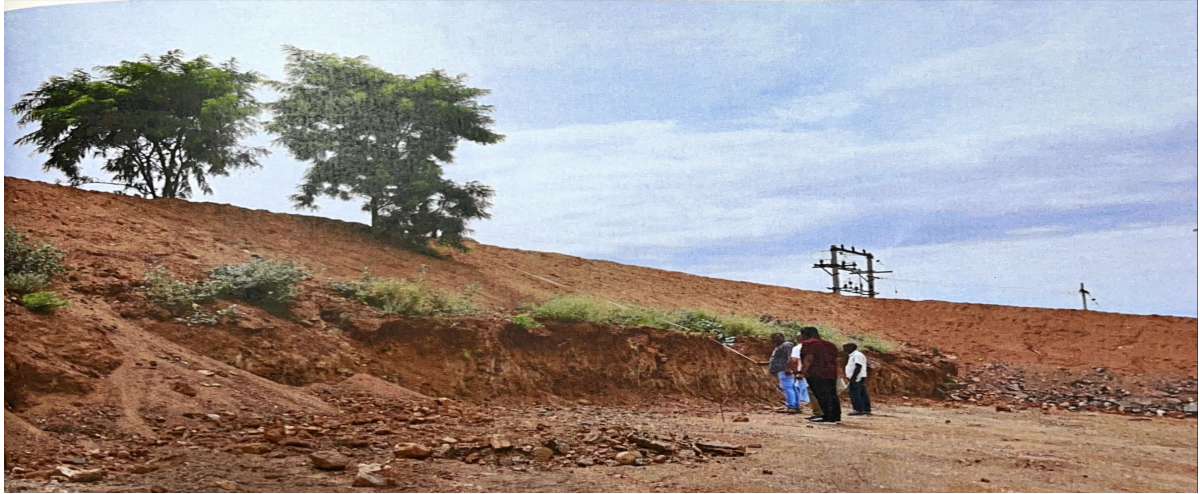
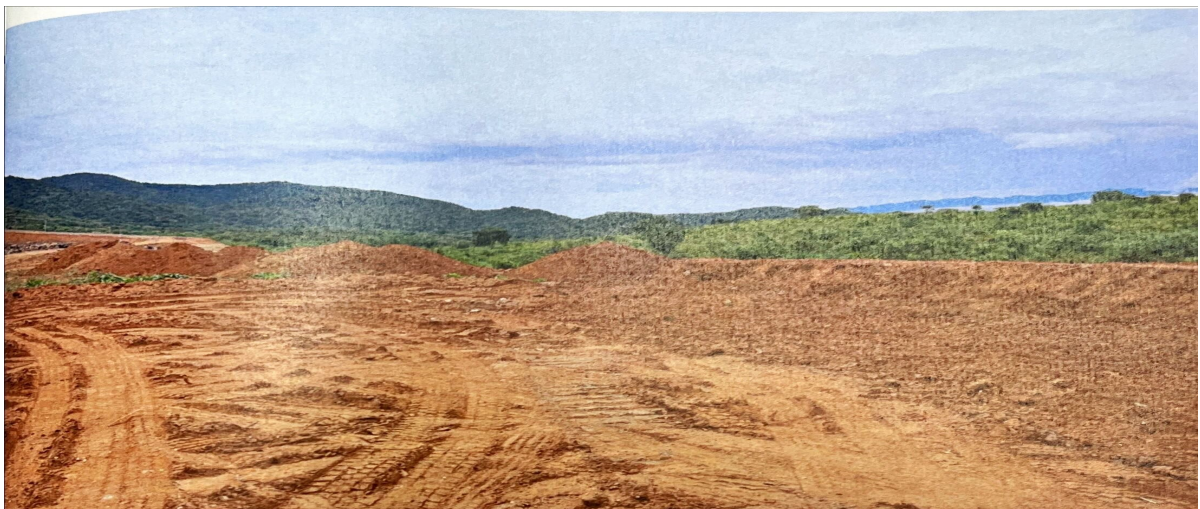
29. The Reserve Forest is located just 500 meters away from the boundary of this land. The inspecting authority inspected S.F.Nos.815 and 816. These lands were originally classified as hill in the revenue records, however, individual names have also entered as if they are their patta land. The hills disappeared and everything seems to be levelled. The manner, in which, these lands are being levelled and the original terrain altered can be known from the following pictures:-

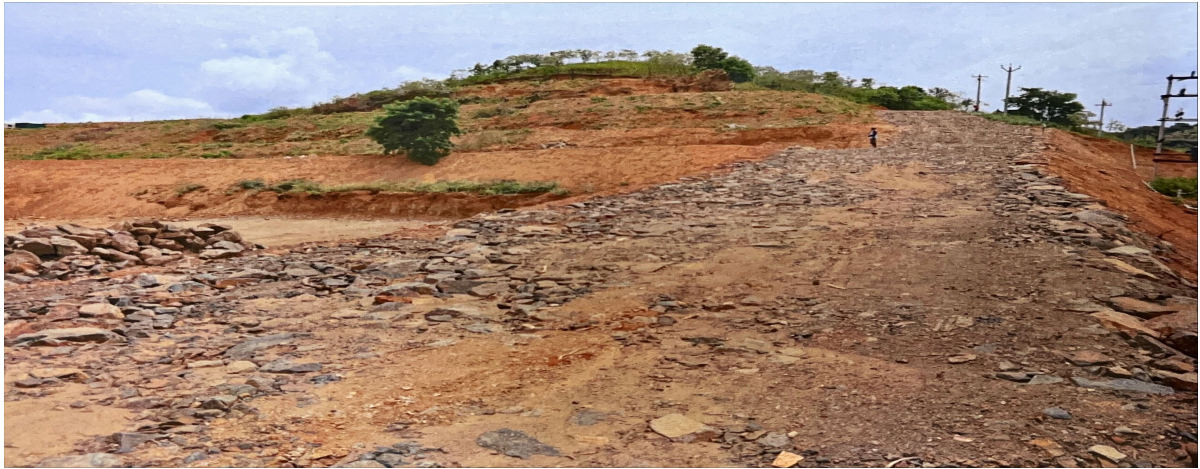
30. The illegal miners have become a Government on to themselves and even formed road by using stones and gravel and the following picture would reveal the same:-

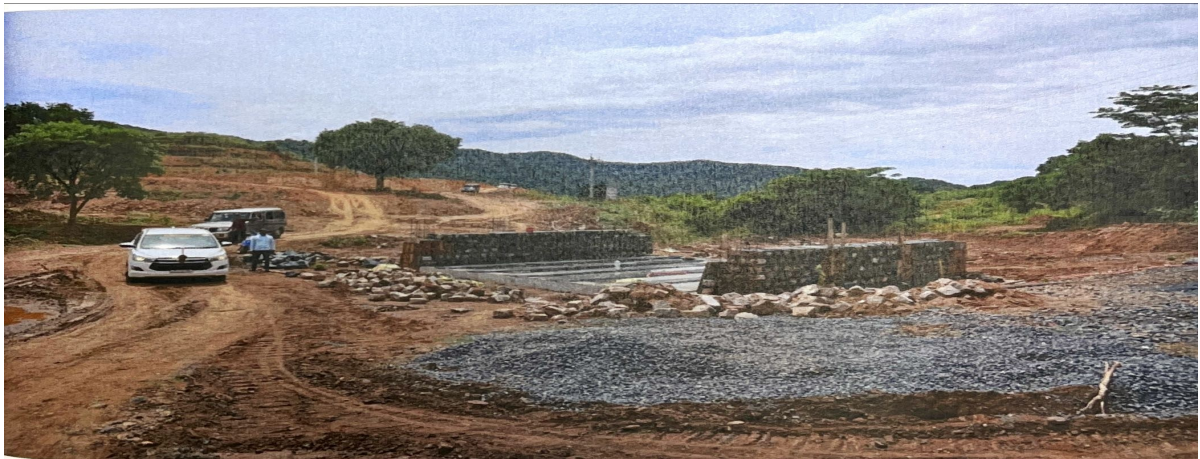
31. Not stopping with that, they are obliterating a live stream and are also constructing a bridge across the same. The following picture would demonstrate the same :-

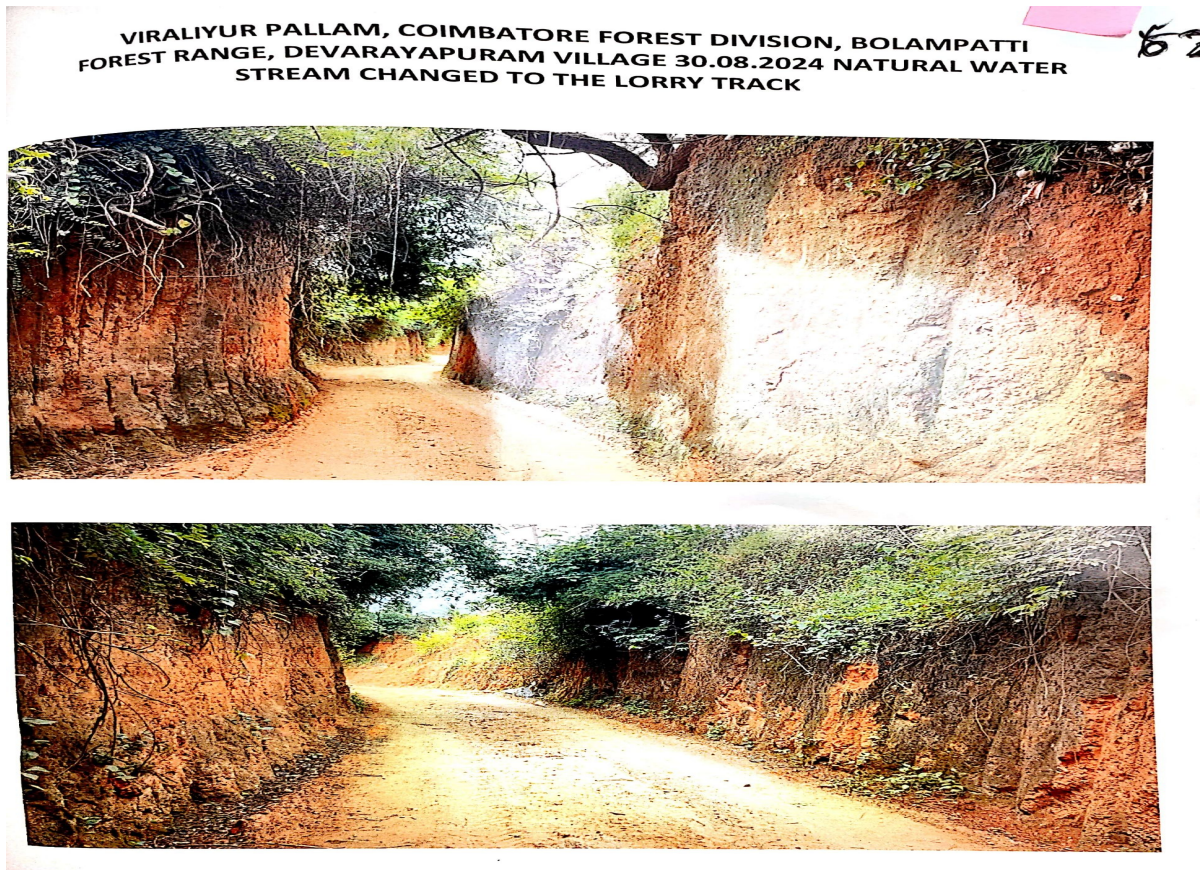
trenches likes the ones below have to be closed enabling the animals/elephants to pass through:-

54. As undertaken, in paragraph No.15 of the status report, the present area shall also be included for the ongoing study of environmental compensation and remediation. As undertaken, a drone survey shall be conducted and accurate estimate of all the places of illegal mining shall be unearthed and cases be registered and a total extent of illegal mining be brought on record before this Court periodically. The information shall be given to the Special Investigation Team, which will register the Additional First Information Reports, as and when necessary and investigate into the same. After the survey of damages is over, the sites to be videographed and the
